# 3-SDU Version 4.01 Release Notes

© 2011 UTC Fire & Security. All rights reserved.

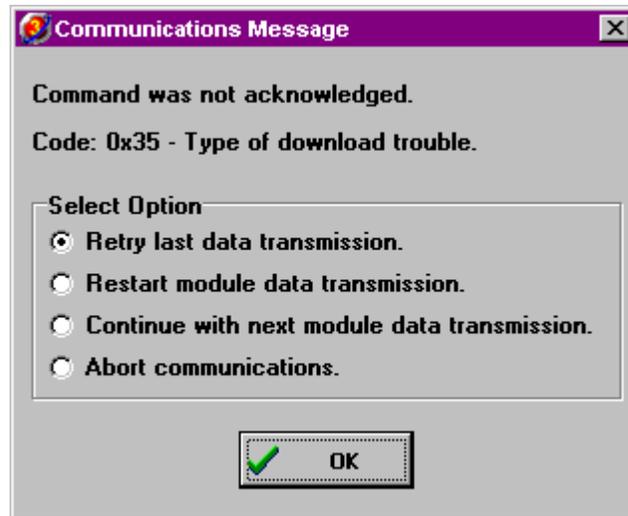
Figure 1: Loop controller communications error message

The SDU displays error code 0x35, shown in Figure 1, when downloading application code to a loop controller that has incompatible boot code.

Verify that the loop controller has boot code compatible with 3-SDU V4.01. For more information, see “5. Software versions and compatibility” on page 12 and “8. Upgrading microcode versions to 4.0” on page 18.

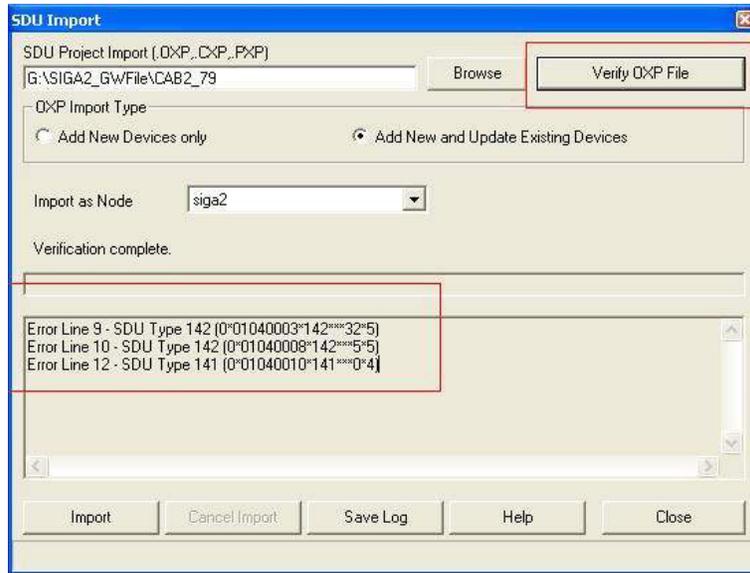
**Figure 2: SDU Import errors (types 141 and 142)**

You can verify the data in your import file from the SDU Import window. Click the Verify OXP File button to view data in the OXP file that FireWorks cannot understand. See Figure 2.

FireWorks versions 1.60.01 and earlier have a compatibility issue with 3-SDU version 4.01, regarding data imported from CO devices and split configuration modes on SIGA2 model detectors only. Since FireWorks does not recognize the CO devices or elements in a split configuration, it reports “undefined errors” for those devices/elements. Note: Split configurations are selected in the Operations option on the Signature Series Configuration – Detectors tab.

- SIGA2-HCOS activations import as a normal Heat detector activation. CO activations import as undefined errors.
- SIGA2-PHCOS activations import as a normal Photo detector activation. CO activations import as undefined errors.
- SIGA2-PCOS activations import as a normal Photo detector activation. CO activations and supervisory activations import as undefined errors.
- SIGA2-PHS activations import as a normal Photo detector activation. If the device is configured as anything other than ‘Photo/Heat is Alarm’ activations import as undefined errors.
- SIGA2-COS activations import as undefined errors.

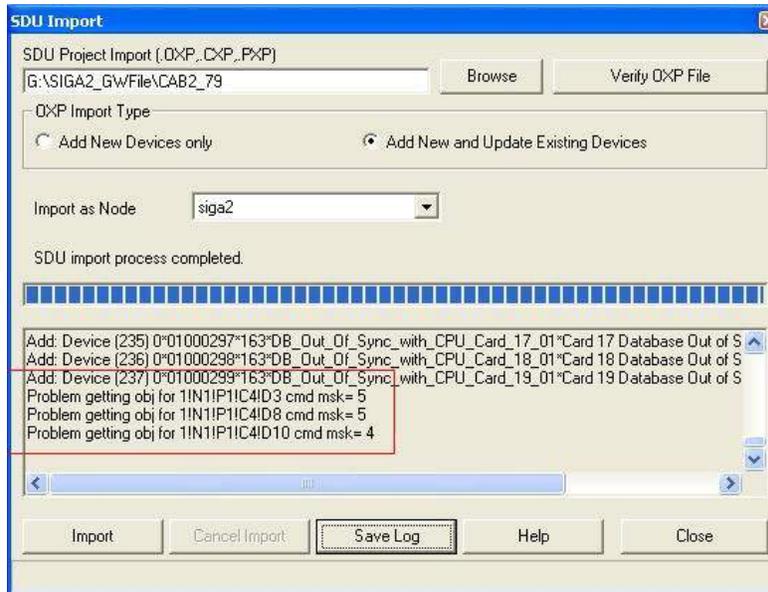
**Figure 3: SDU Import undefined device messages**

When the import finishes, FireWorks lists the devices that it could not define. See Figure 3.

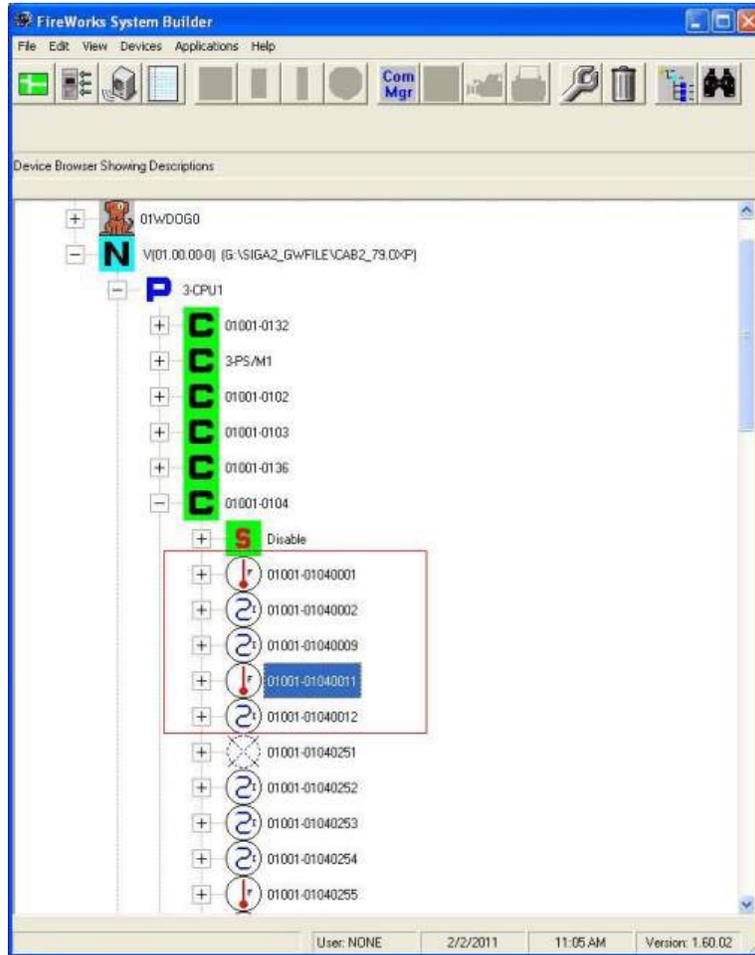
Figure 4: System Builder sequence interruption due to unrecognized devices/elements

Since FireWorks cannot understand these devices, it does not include them in the System Builder tree. Therefore, the device list may no longer be numbered logically. See Figure 4.
